Volkswagen

Comparison of Product and Repair Costs for Golf VII Body Parts – Crash Test.

Comparison of product and repair costs for body - test performance 2016

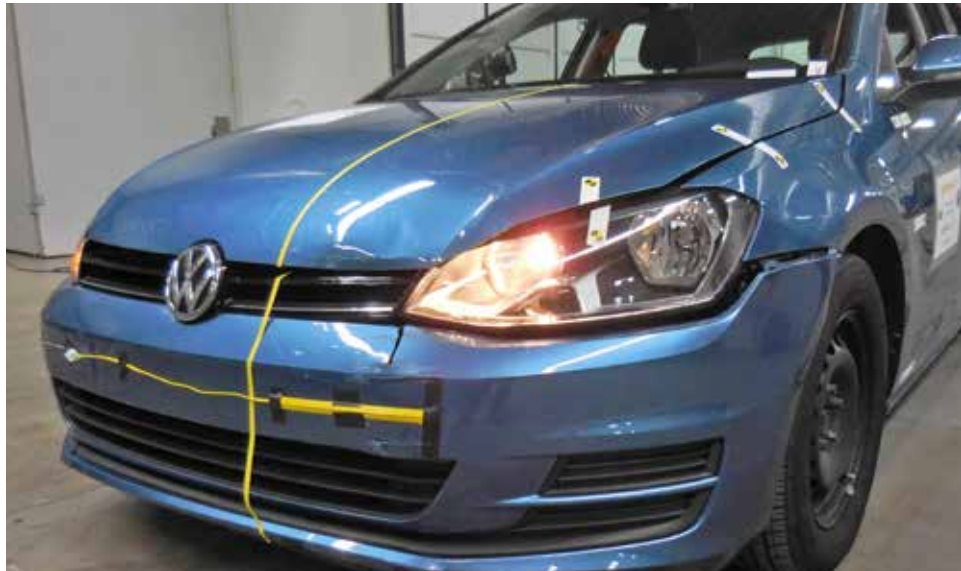
Golf VII equipped with Genuine Parts after the crash test.

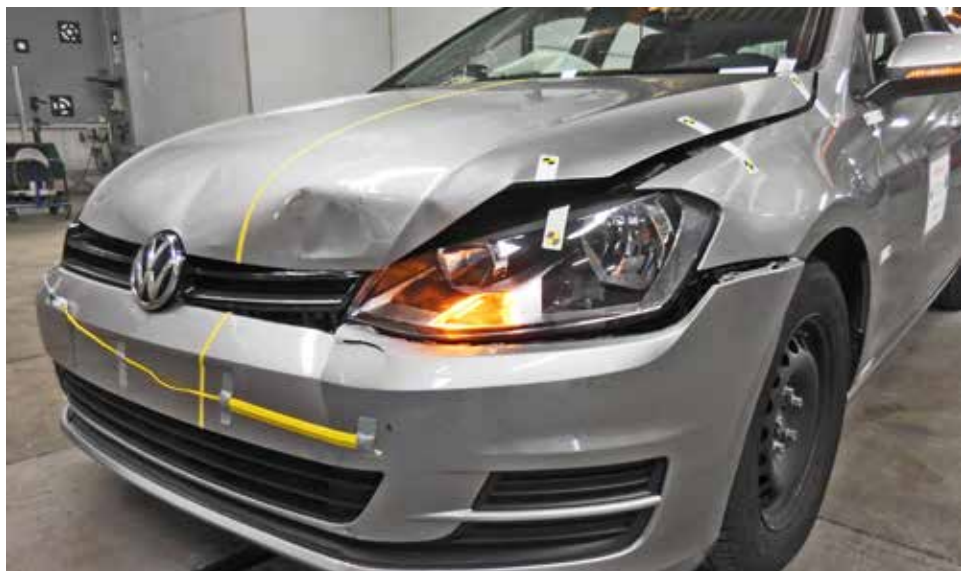
At first sight, the Golf VII equipped with competitor parts already shows a visibly higher level of damage after the crash test, which indicates serious qualitative differences to Genuine Parts.

Golf VII equipped with IAM parts after the crash test.

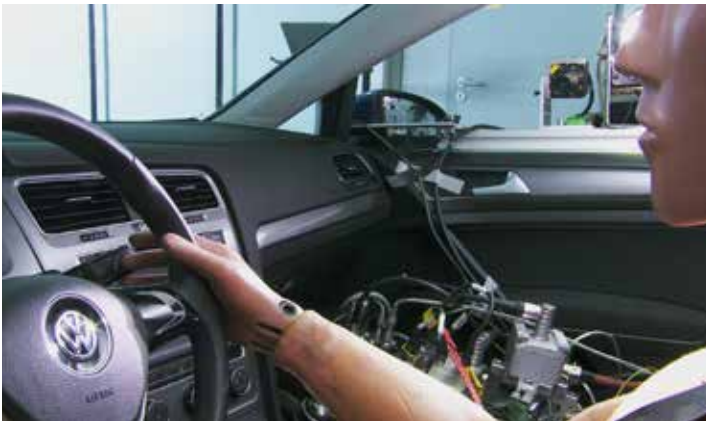
Golf VII interior with Genuine Parts post-crash.

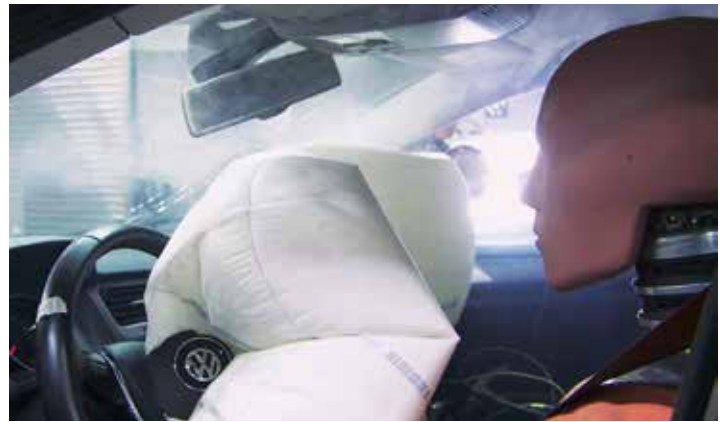
Airbags triggered. Golf VII interior with IAM parts post-crash.

In the case of the competitor tested, these differences lead to visibly worse deformation behaviour in the cross member. The consequences: In the crash test it cannot absorb a sufficient level of impact energy, which results in the test vehicle becoming strongly damaged and even triggering the airbags.

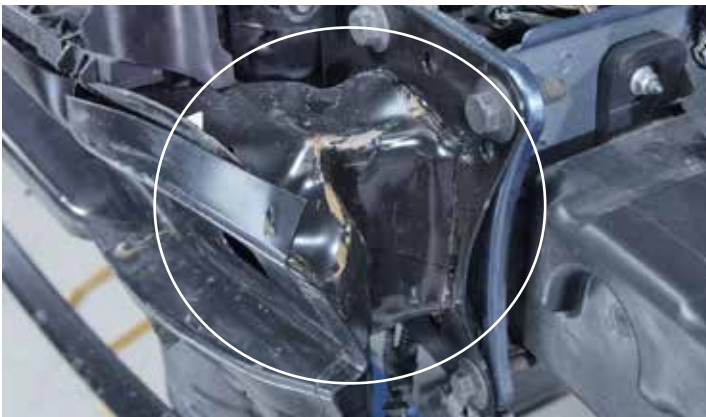
- Crashbox measurement: previously 114 mm, afterwards 77 mm

Golf VII with Genuine Parts. Crashbox dented by 37 mm after the crash.

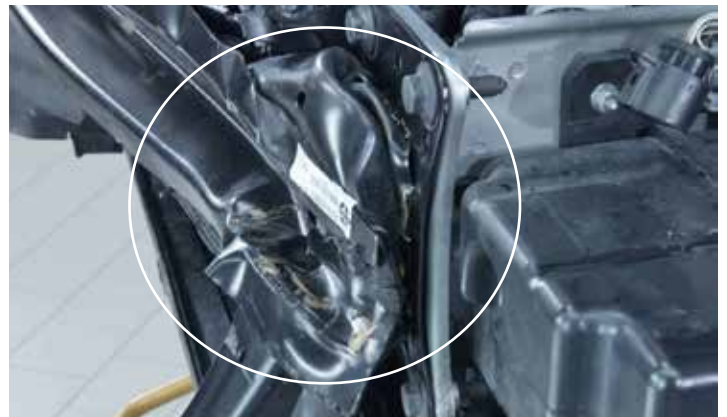
- Crashbox measurement: previously 114 mm, afterwards 34 mm

Golf VII with IAM parts. Crashbox dented by 80 mm after the crash.

In the crashbox area, the IAM cross member from manufacturer Yih Sheng has a material strength of only 65% compared to the Genuine Part. Even more significant is the difference when it comes to the strength of the cross member element: while the Genuine Part reaches a value of 1,400 megapascal (N/mm²) here, the IAM part tested reaches no more than 300 megapascal (N/mm²), i.e. around 21%. Additionally, the cross member tested in the crashbox area did not show any welding points, instead only showing gas-shielded welding seams. These are meant to offset the lacking fit accuracy of the individual parts.

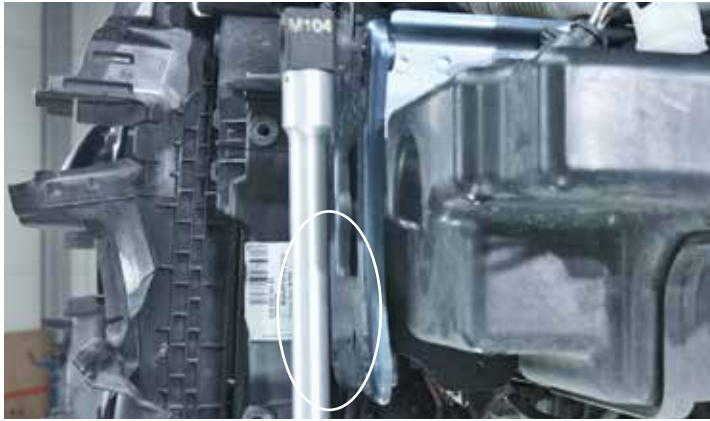
Golf VII with Genuine Parts. Flange after the crash: no adjustment work required.

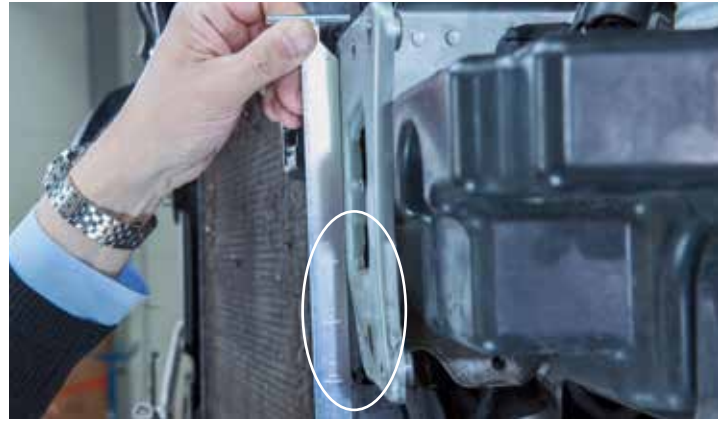
Golf VII with IAM parts. Flange after the crash: adjustment work required.

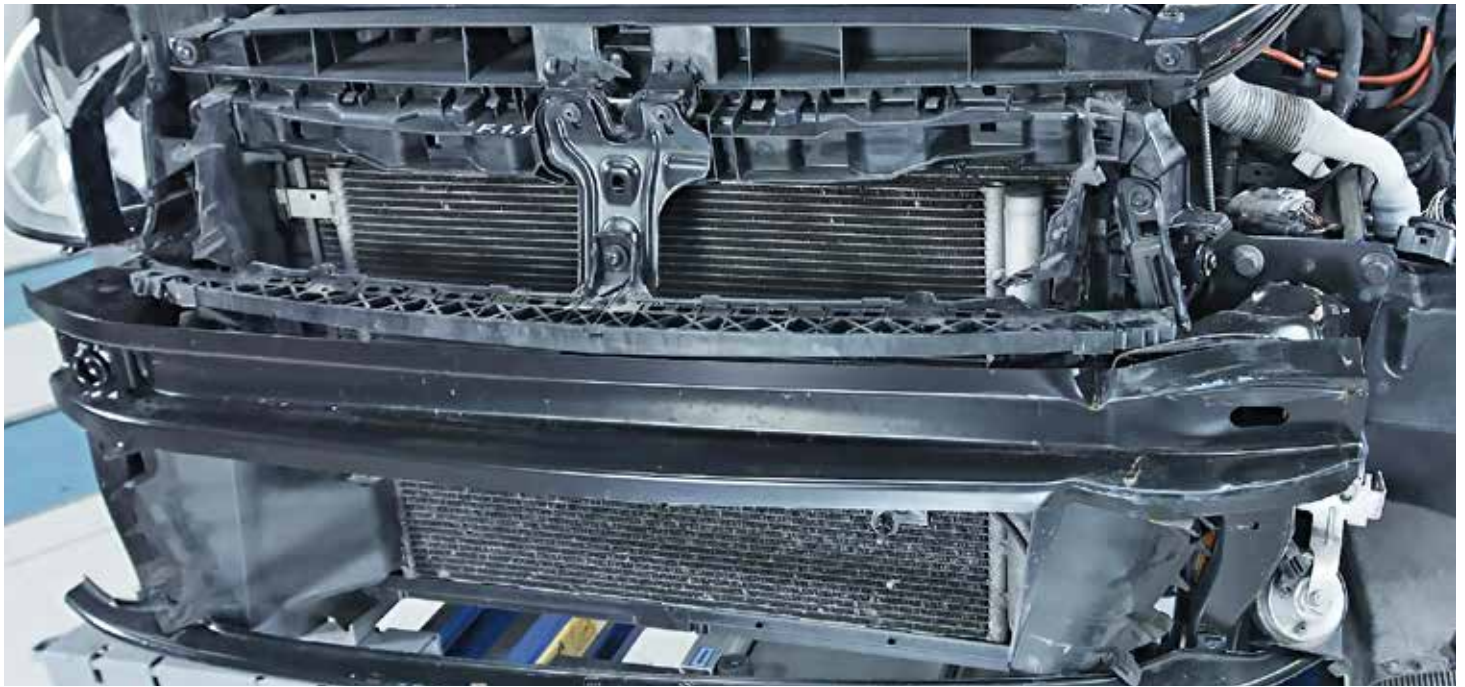
- Present at front right and left
- Bonnet, left headlight, radiator grille and bumper cover
- Front mask as well as right and left front mask struts
- Bumper absorbers and support
- Radiator airflow left and right
- Mud guard
- Gap dimensions from right and left mud guard to door consistent
- Gap dimensions from mud guard to left of bumper not accurate
- Gap dimensions from right and left mud guard to bonnet accurate
- Lid lock

Golf VII with Genuine Parts. Damages to the front after the crash.

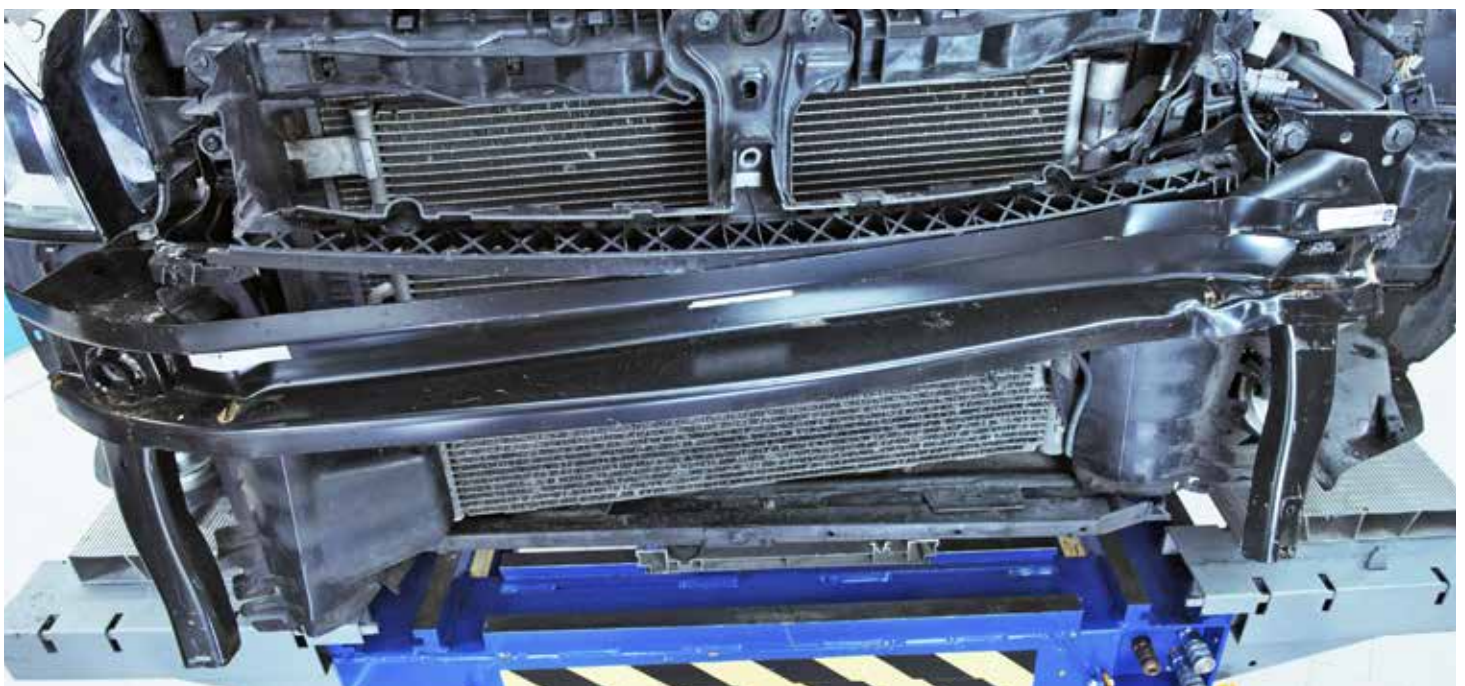
- Present at front right and left
- Bonnet, left headlight, radiator grille and bumper cover
- Right and left front mask panel struts
- Bumper cover, absorbers and support
- Defective radiator airflow on left and right, air filter on intake pipe also affected
- Gap dimensions from right mud guard to door consistent, from left mud guard to door inconsistent
- Gap dimensions from left mud guard to bumper are inaccurate
- Gap dimensions from right mud guard to bonnet are inaccurate
- Driver airbag, passenger airbag and knee airbag triggered; windscreen and dashboard are damaged
- Paint damage on driver door and right mud guard
- Left mounting for impact attenuator (flange) deformed

Golf VII with IAM parts. Damages to the front after the crash.

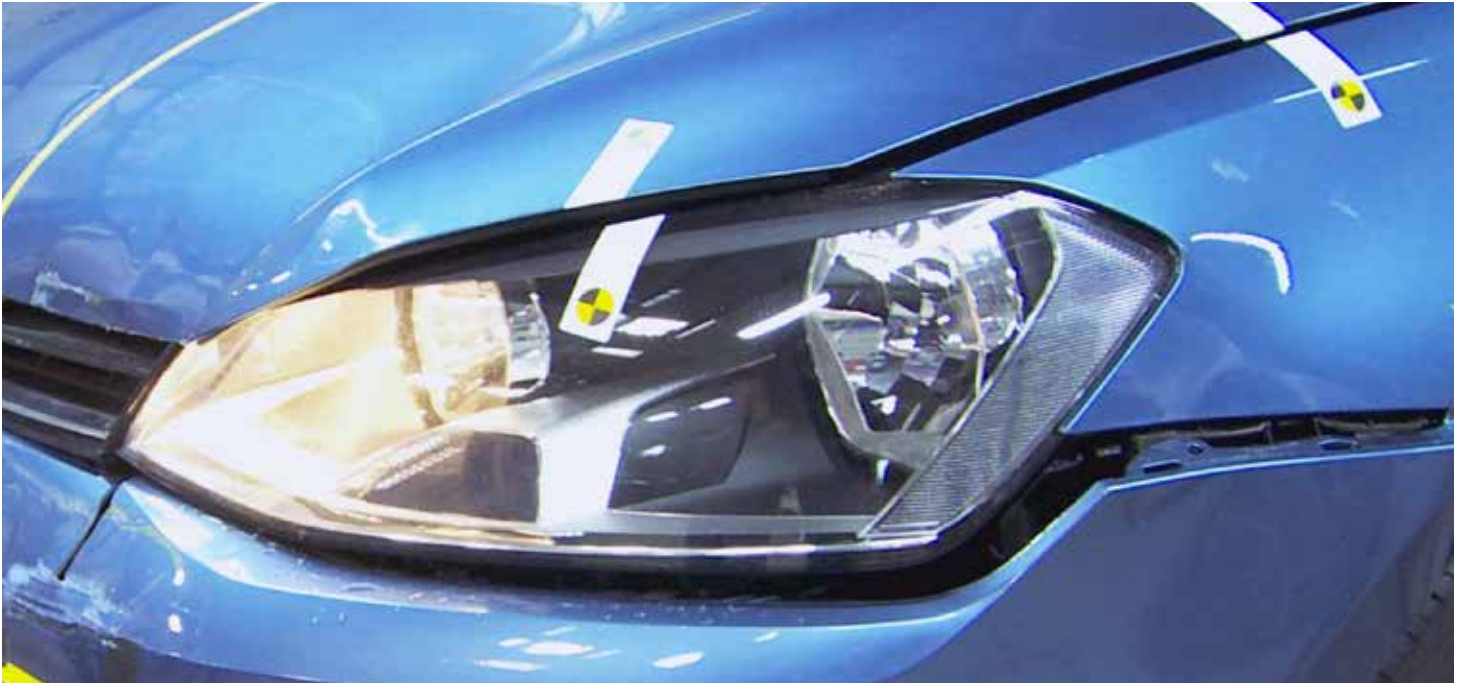
Golf VII with Genuine Parts. Deformations after the crash.

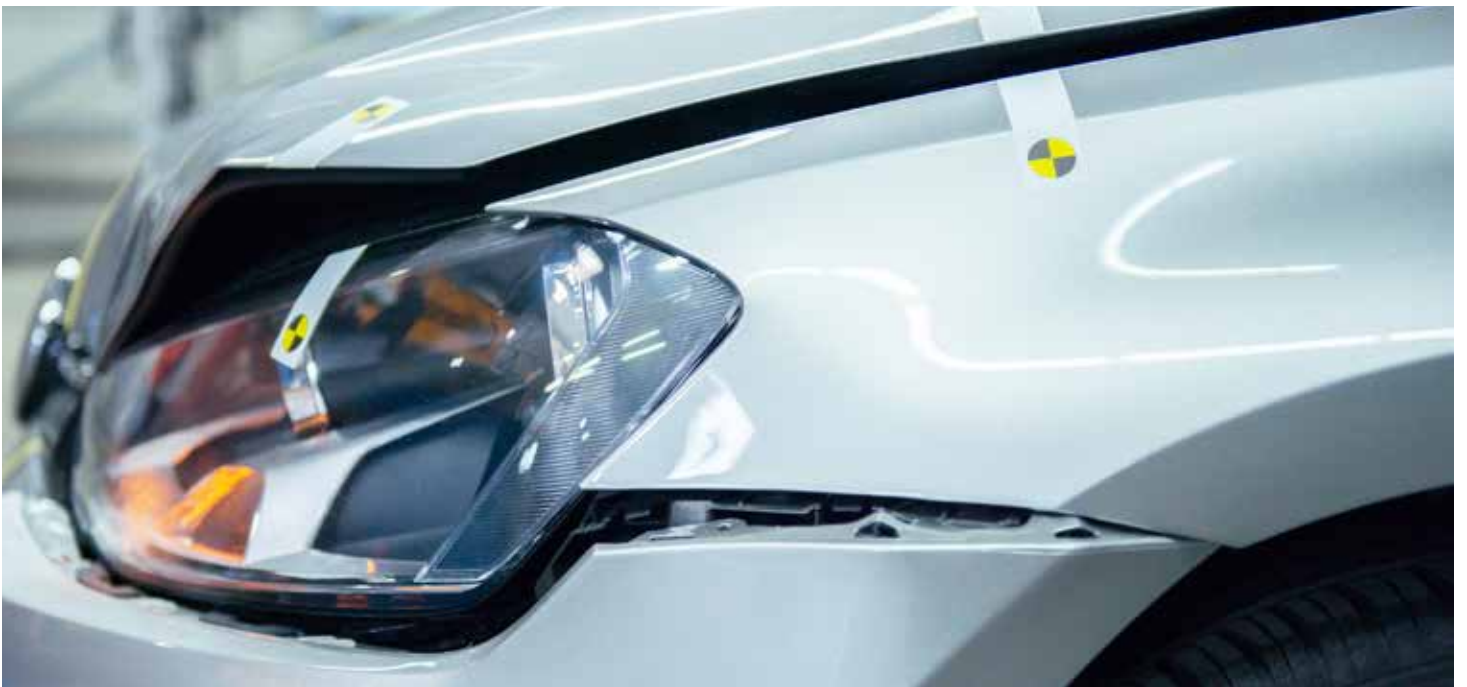
The second body frame measurement of the Golf VII equipped with IAM parts also showed a measurement point outside of the manufacturer's tolerance after the crash test: this difference also had to be repaired, which in turn increased repair costs. All relevant measurement points on the test vehicle equipped with Genuine Parts were identical before and after the crash test.

Golf VII with IAM parts. Deformations after the crash.

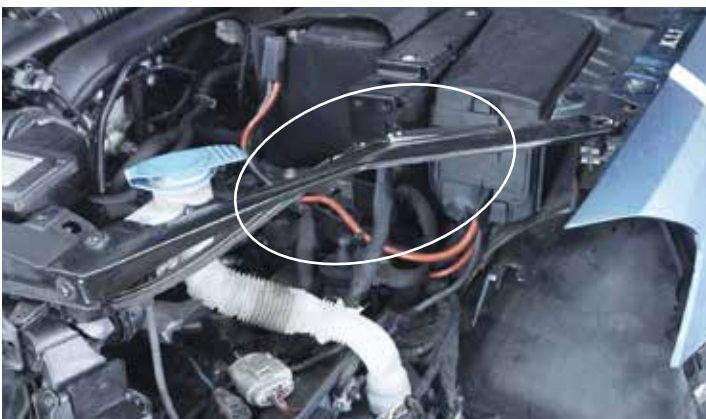
Golf VII with Genuine Parts. Front mask mounting after the crash: lightly bent.

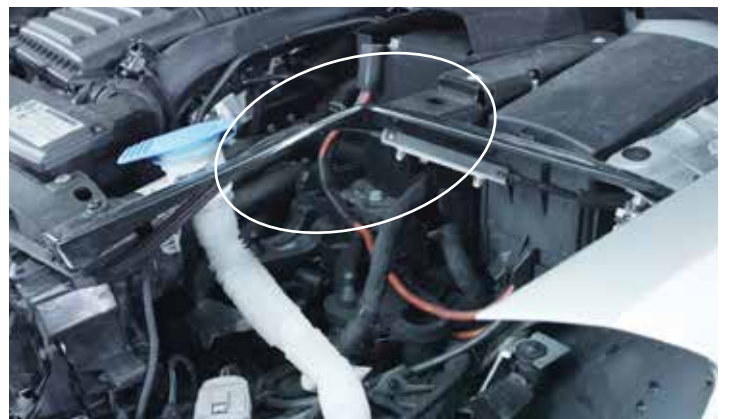
Golf VII with IAM parts. Front mask mounting after the crash: highly bent.

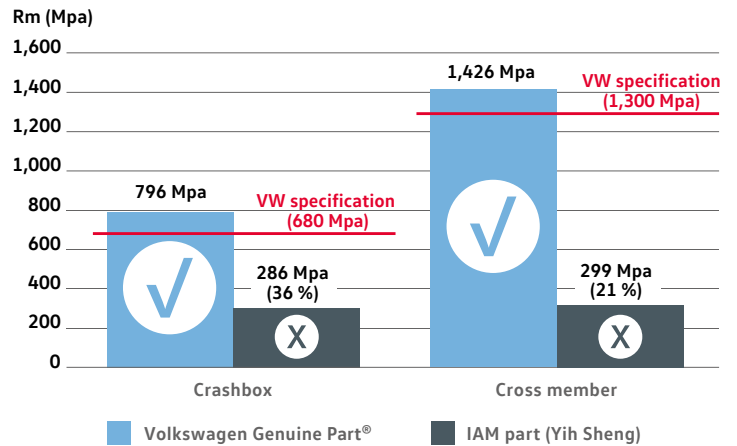
Tensile strength of cross member

The graph shows a visible difference in tensile strength:

- The tested IAM crashbox only had 36% of the tensile strength of the Genuine crashbox (see graph)
- Even more significantly, the tested IAM cross member only had 21% of the tensile strength of the Genuine cross member (see graph)

- The tested IAM crashbox had 65% of the material strength of the Genuine crashbox
- The tested IAM cross member had 87% of the material strength of the Genuine cross member

- Inconsistent welding seams on the cross member
- Only gas-shielded welding seams in the crashbox area, instead of regular welding seams. Potential consequence: lower crashbox resistance.

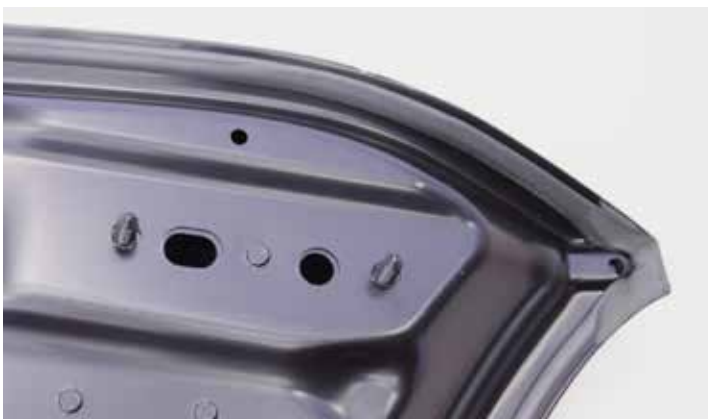
Volkswagen Genuine bonnet with seam sealing.

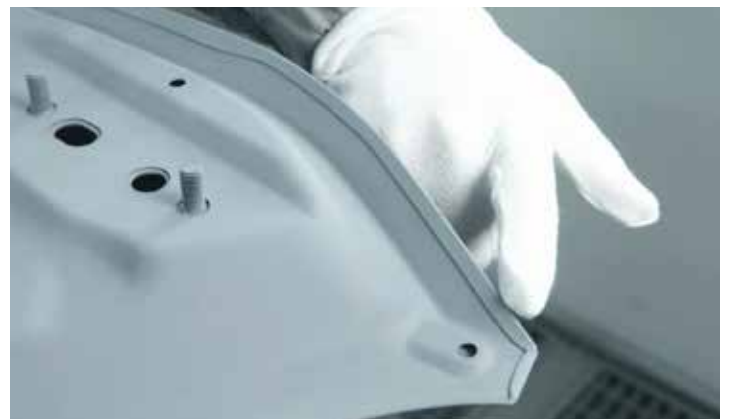
While the IAM bonnet tested had no significant weight difference compared to the Genuine Part, it displayed other, partly considerable differences. For example, unlike the Genuine Part, it was not equipped with a layer of zinc to protect against corrosion (red rust).

The seam was also unsealed, which can result in moisture penetrating the seam and joining area between the exterior and interior construction of the bonnet and cause crevice corrosion. The stiffness of the bonnet also decreases through this, which can have negative consequences for the stability of the vehicle structure in a high-speed accident.

- No zinc layer (corrosion)
- Seams unsealed
- Unclean bonds on exterior and frame

IAM bonnet from manufacturer Tong Yang Group without seam sealing.

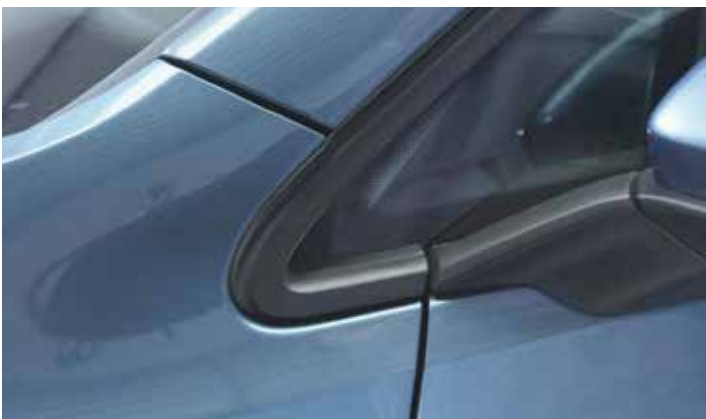
Volkswagen Genuine mud guard.

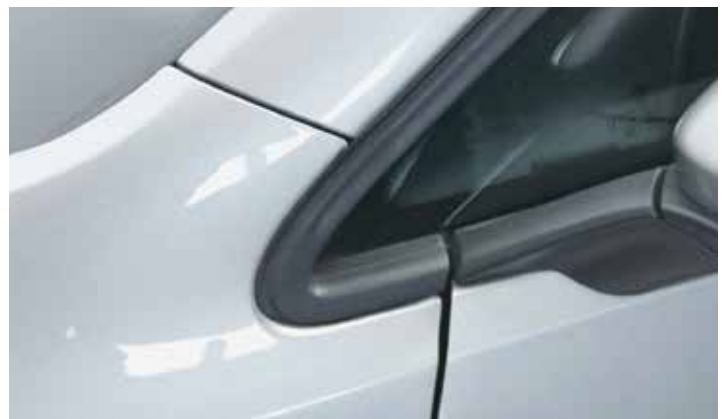
The fit of the mud guard tested was insufficiently accurate in all areas (A-pillar, door, bonnet), had sharp edges and undulating fixing edges. Like with the cross member, a zinc layering was also absent, which can contribute to corrosion through red rust. Finally, the IAM part was 20 % heavier than the Genuine Part. This indeed increased fuel consumption and CO₂ emissions and did not increase the strength of the mud guard, as evident in the tension test. Thus the IAM part tested in this instance also did not provide any cost benefits for insurers or vehicle owners.

- Deficient fit accuracy and consequently higher assembly costs
- No zinc coating (corrosion)
- Sharp edges
- Undulating fixing edges
- 20 % heavier than the Genuine Part

IAM mud guard from manufacturer Gordon.

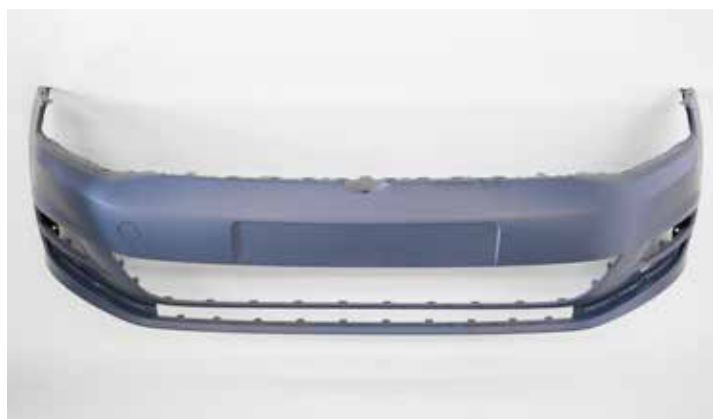
Volkswagen Genuine bumper trim with primer.

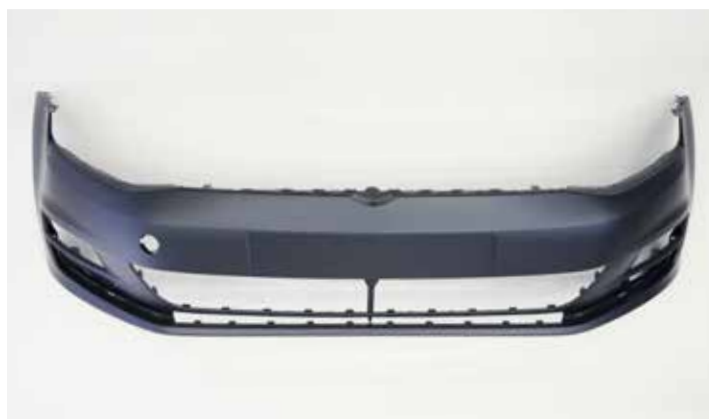
The bumper trim was 10 % lighter than the Genuine Part and had sharp edges. The bad deburring was also evidence of less than diligent workmanship. In particular, however, primer - essential for this component - was absent. Because of this, paint does not keep as well on the bumper trim's plastic surface, which has a negative impact on the vehicle's appearance and thus its value.

- Impact energy absorption 50 % lower in accidents than with the Genuine Part
- 10 % lighter than the Genuine Part
- Sharp edges
- Bad deburring
- No primer for paint application

IAM bumper trim from manufacturer I.S.A.M. S.p.A. without primer.
