Volkswagen

Comparison of Product and Repair Costs for Golf VII Body Parts – Crash Test.

Comparison of product and repair costs for body - test performance 2016

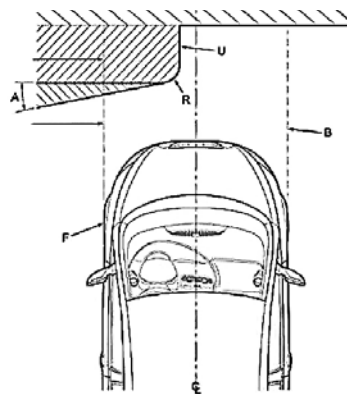
RCAR Standard for crash compliance

- U = 40 % overlap
- B = vehicle width (front)
- R = 150 mm radius
- F = test vehicle
- A = 10° barrier angle

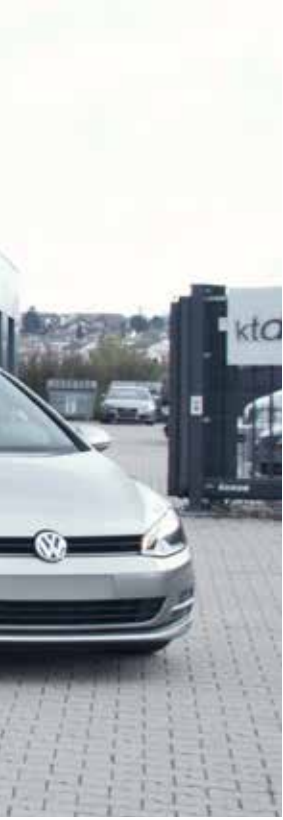
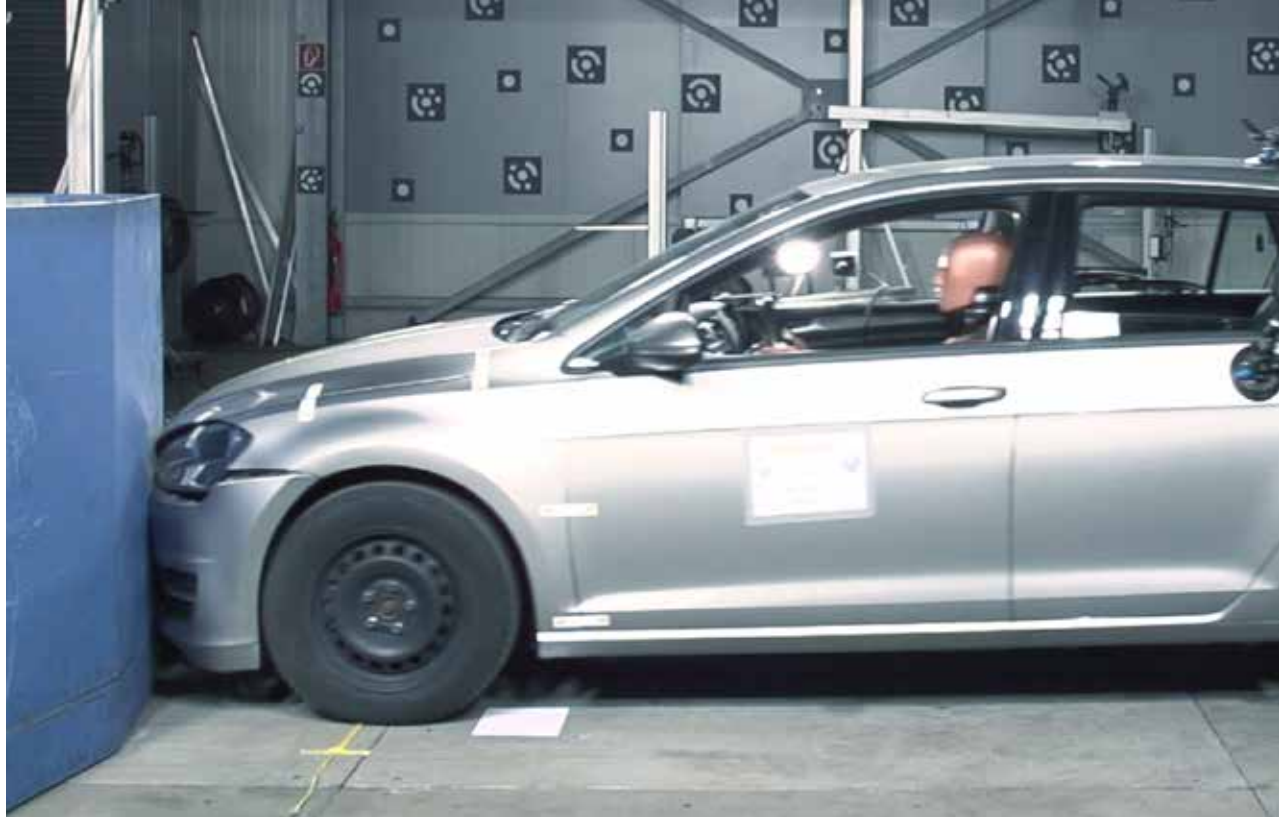
Golf VII equipped with Genuine Parts after the crash test.

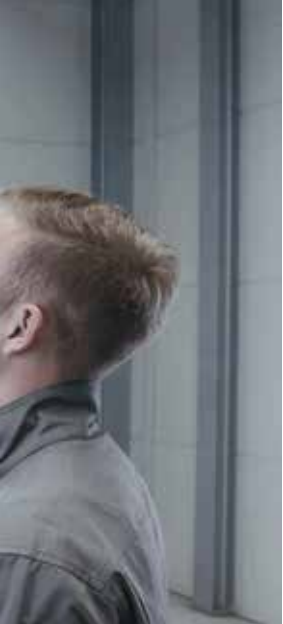
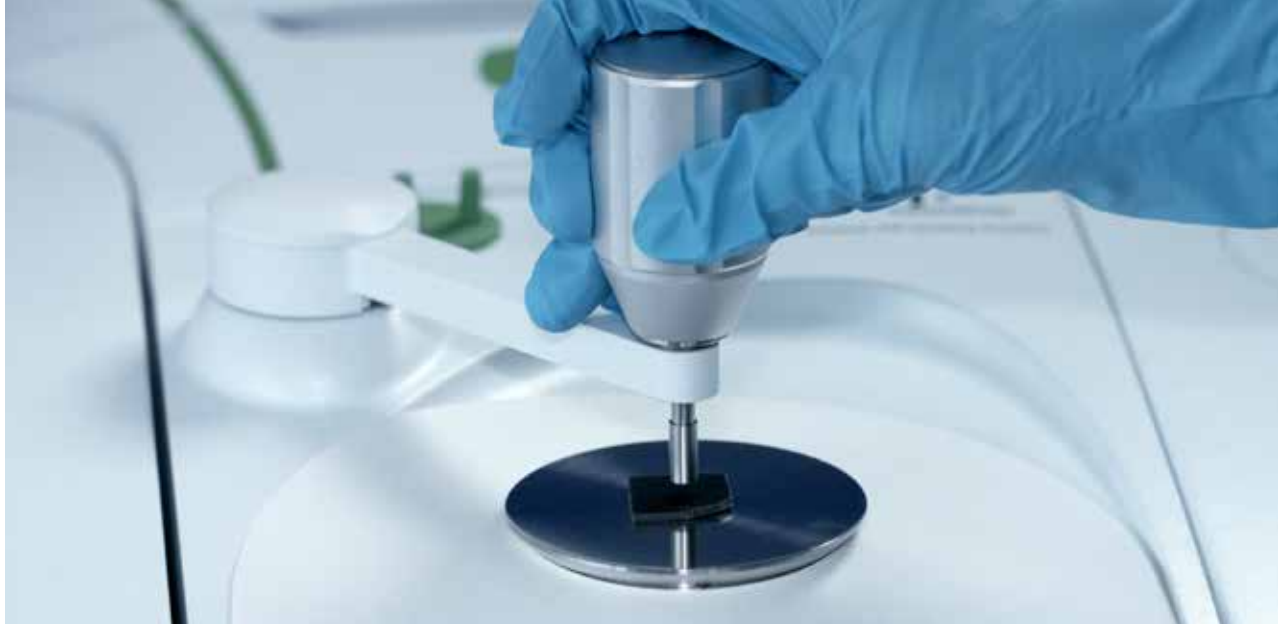
The front mask: Small differences.

Aside from a small weight difference, the tested IAM front mask from manufacturer Tong Yang Group did not show any other differences. The material composition was in line with specifications and the replacement costs were almost identical to those of the Genuine Part.

- 5 % lighter than the Genuine Part
- No other differences
